Test report of BFRP rebar in marine environment

Testing the performance change of
**Basalt Fiber Reinforced Polymer (BFRP) rebar after
6 months exposure to ocean splash zone**

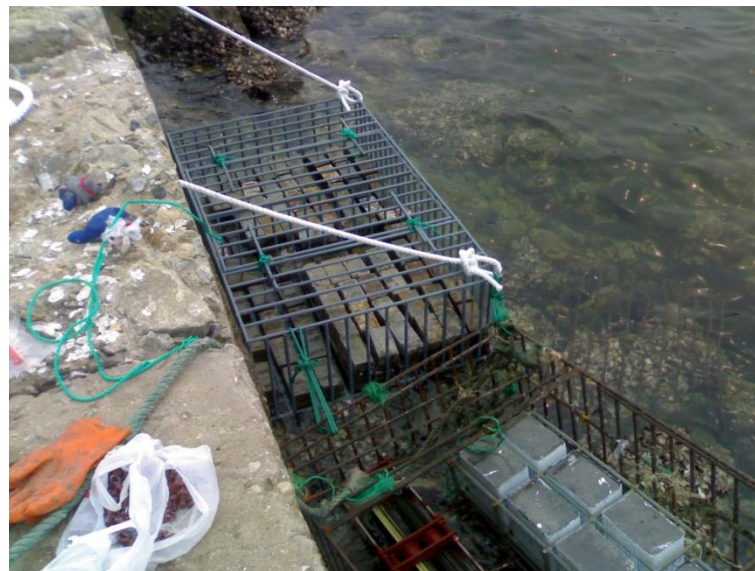
Figure 1: Sample: **BFRP** durability test in ocean splash zone.

Note: corrosion has been shown to accelerate in seawater / salt-spray environments with the crashing of waves.

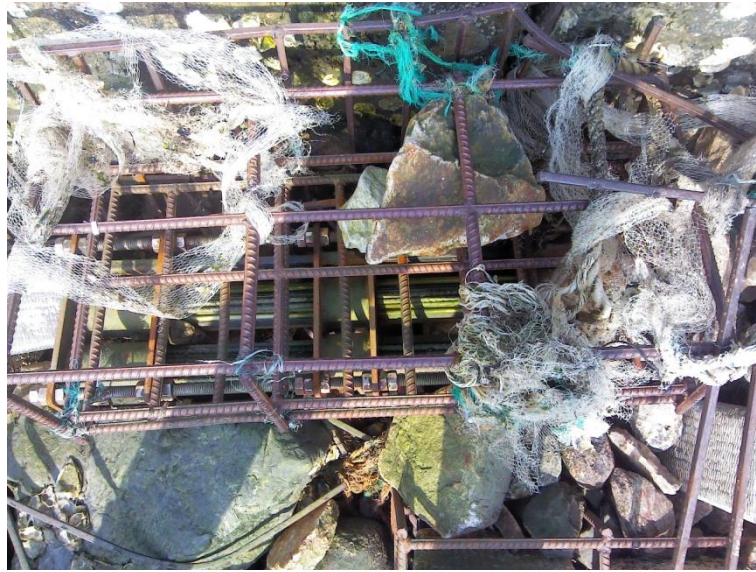
Figure: 2 shows appearance after 6 month and still inside the iron test cage (shown drying out at the ebb tide)

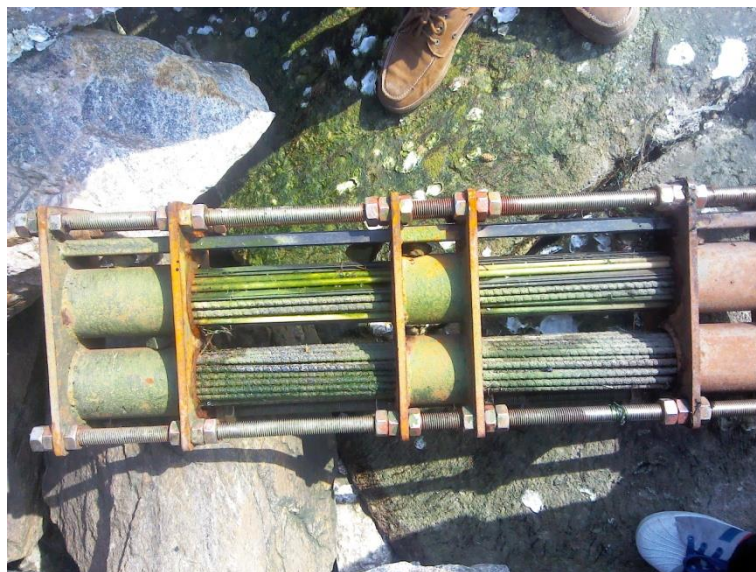
Figure: 3 Specimens of 8 mm RockRebar™ test sections appearance after removal from 6 months in iron cage and exposed to ocean splash zone shows only green moss.

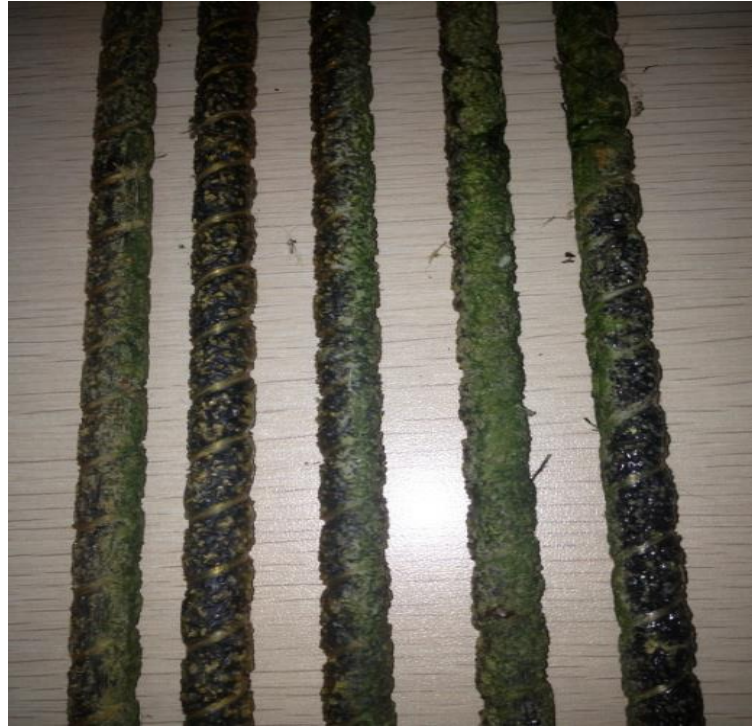
Figure: 4 shows the rebar removed from the test cage and clamp fixture after 6 months of ocean splash zone exposure. Surface appearance of the rebar has nearly “no change” only some moss, the quartz sand is good, no fiber is exposed, which stated that resin matrix has no degradation.

It can be found that **BFRP** rebar appearance has no obvious change after 6 months corrosion. Its tensile strength improved by 20% when its modulus of elasticity lowered by 5.8%. It indicates that the marine environment has no effect on the degradation of **BFRP** basalt performance.
